**Libby Asbestos Superfund Site
The Former Screening Plant and Surrounding Properties,
Operable Unit 2
Lincoln County, Montana**

Final Remedial Action Report

USACE Contract No. W9128F-11-D-0023

April 20, 2012

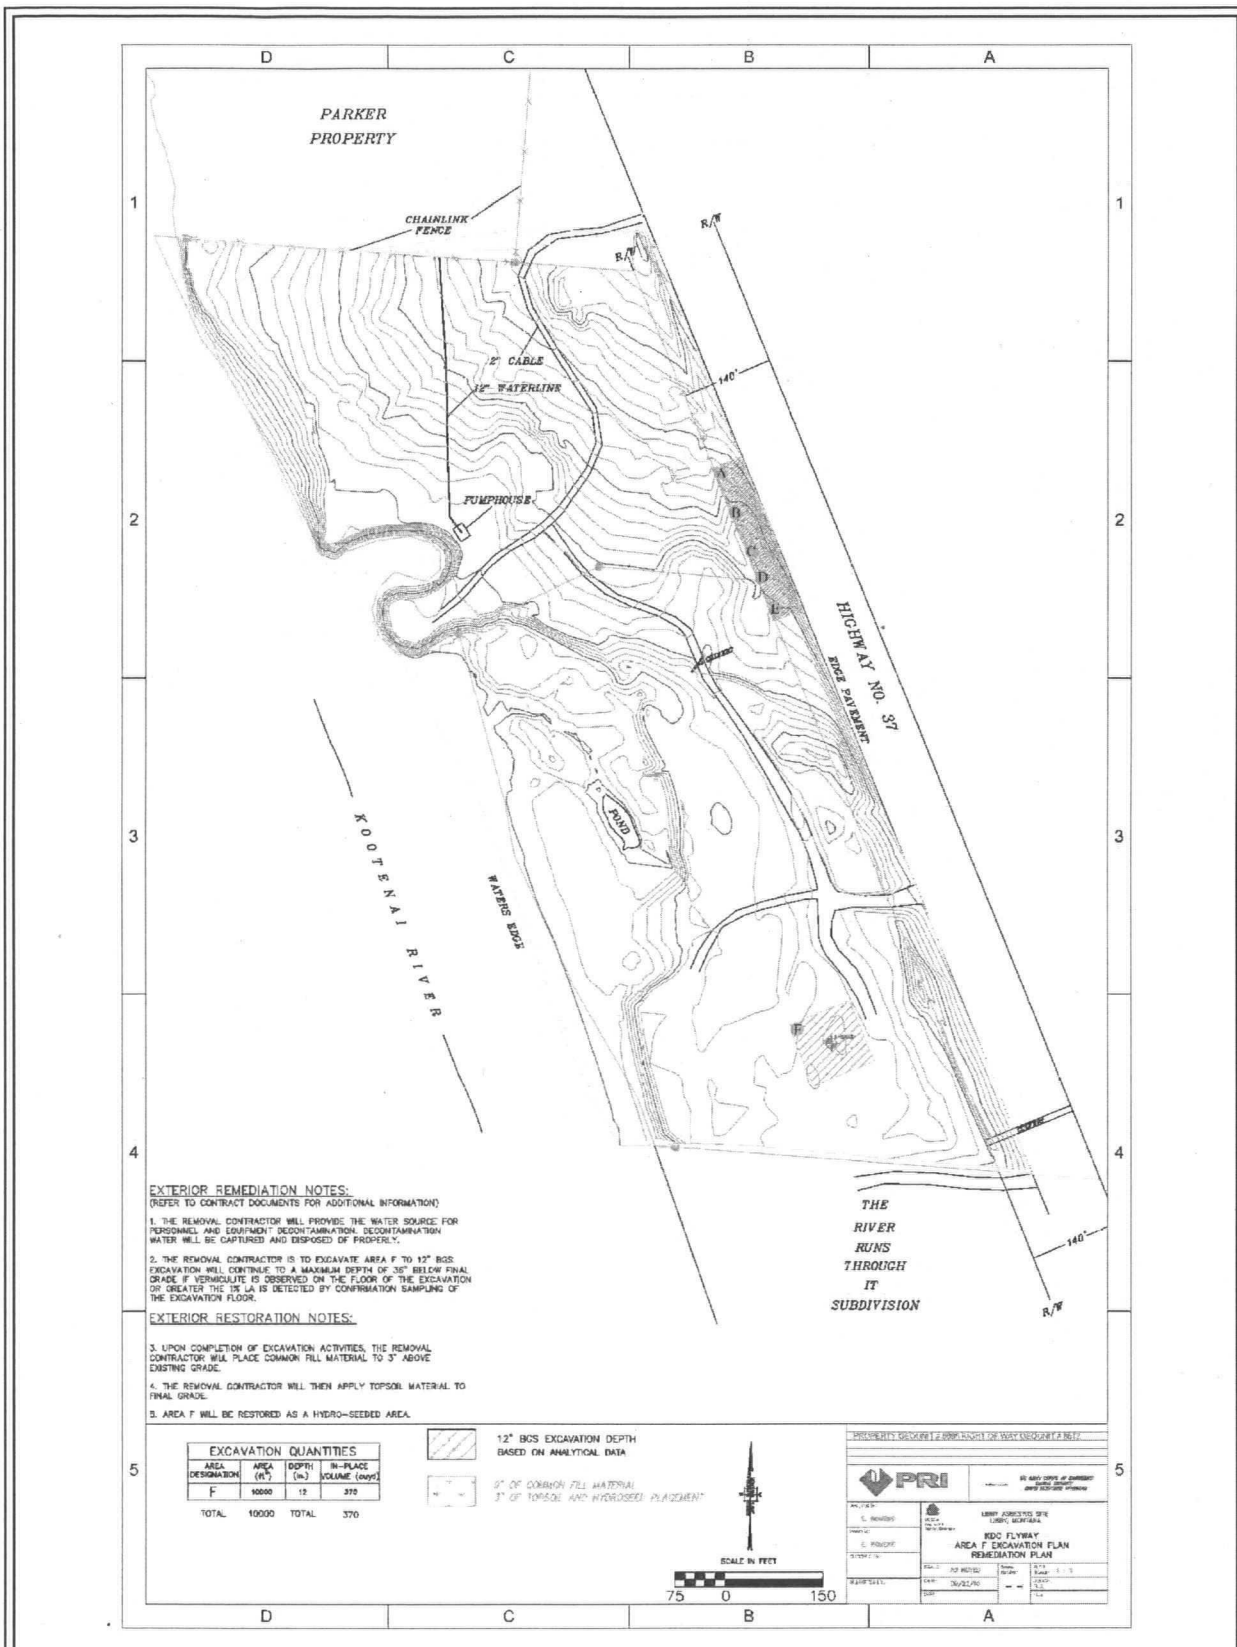
Figure 3-2
Remediation Design
KDC Flyway: Area F
Libby Asbestos Superfund Site
Lincoln County, Montana

A visible marker layer was not placed at the bottom of the excavation prior to backfill. The marker layer was not necessary in Area F because all confirmation soil samples were ND for LA and no visible vermiculite was observed at the bottom of the excavation. The EPA determined that the marker layer was not necessary in Areas A through E because confirmation soil samples contained low concentrations of LA and minor amounts of visible vermiculite.

Area F was backfilled with 9 inches of common fill, placed and compacted in 3- to 6-inch lifts, followed by an additional 3 inches of topsoil. Restoration of Area F began on September 29 and was completed on October 4, 2010. It should be noted that the dates on the Property Closeout Checklists (PCCs) reflect both the ROW and Flyway excavation and restoration. The more specific dates provided in this section are taken from QARs.
